# ENVIRONMENTAL IMPACT ASSESSMENT

## **Jumby Bay Beach: Silt Removal and Replacement**

Antigua, West Indies

*Prepared by:*  
ETC Ltd.  
(Environment Tourism Consulting Ltd.)  
St. John's, Antigua, W. I.

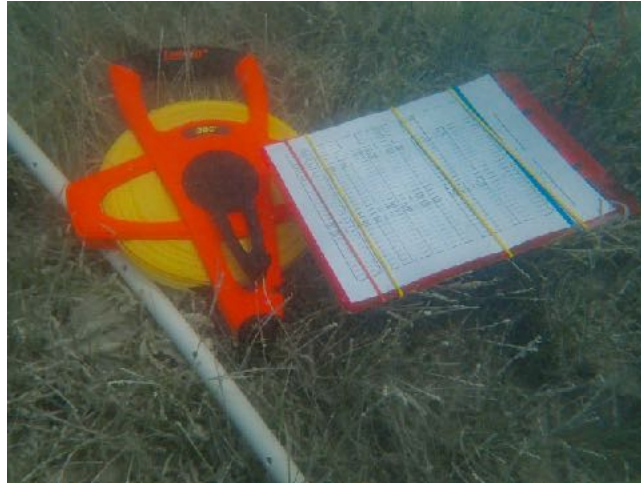
**Photo 1:** Equipment used to Conduct Seagrass Surveys (Camacho, 2021)

To confirm the primary benthic habitat, desk-based analysis concluded the dominant habitat as seagrass. To corroborate these findings, an assessment of seagrass was adopted based on a formal protocol via scuba-diving developed by the Marine Ecologist. This same method has been used to assess seagrass in the Nelson Dockyard National Park. Photo 1 shows the equipment used to conduct these surveys.

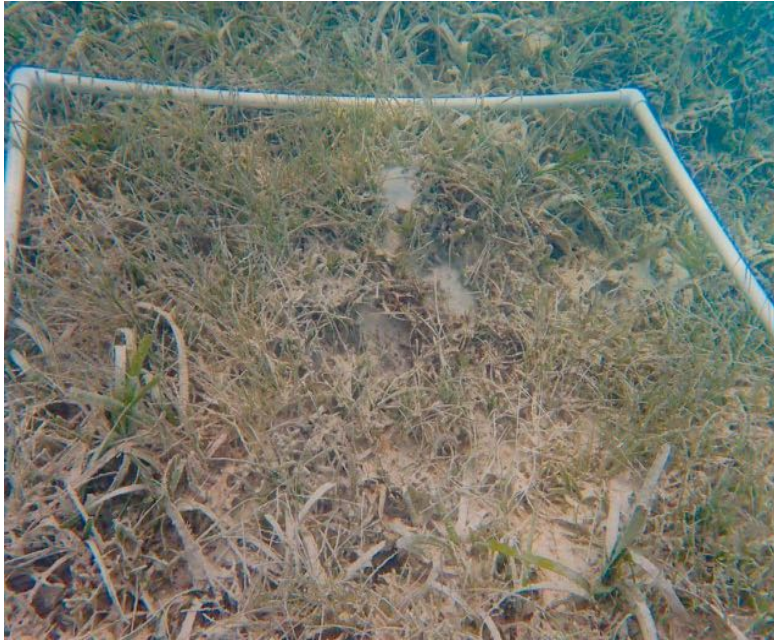
**Photo 2:** Example of Quadrant positioning showing Manatee Grass dominating the transect area (Camacho, 2021)

Transect 1 was conducted nearest to the shore, in an average depth of 3.5ft (1m). Transect 2 was conducted adjacent to the swim platform in the swim area at 6ft (1.8m). Transect 3 was executed beneath the swim line, and the depth average was 5.5ft (1.7m). Photo 2 shows how this was conducted.

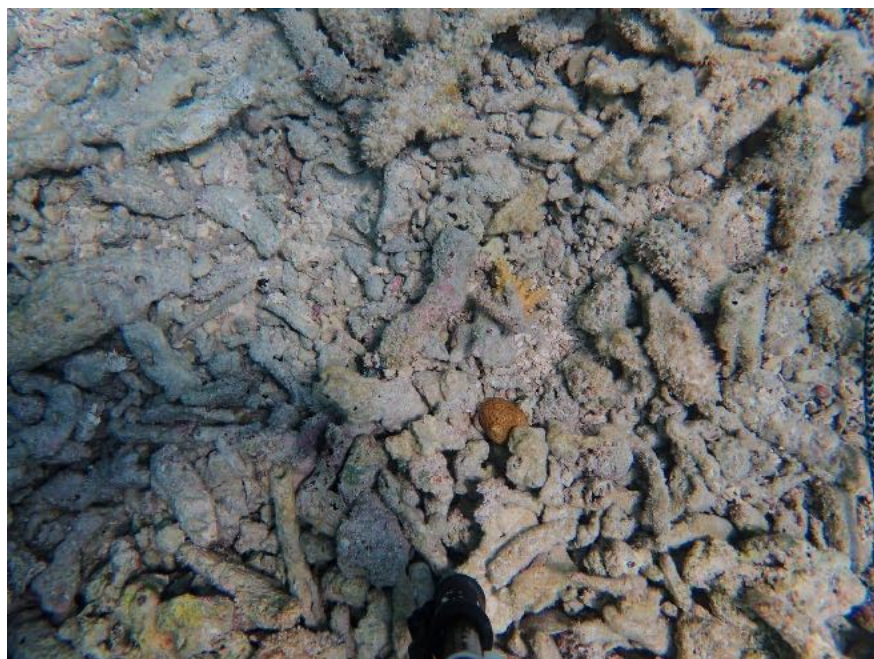
**Photo 4:** Coral Present in T1 Transect (Camacho, 2021)

T1 was carried out on the southern part of the point. The area here is algal dominated as seen in Photo 3, with Dead Coral with algae (49.24%) and Macroalgae (28.90%) accounting for most of the benthic cover. Based on observations, live coral accounted for 0.38% represented in Figure 2.

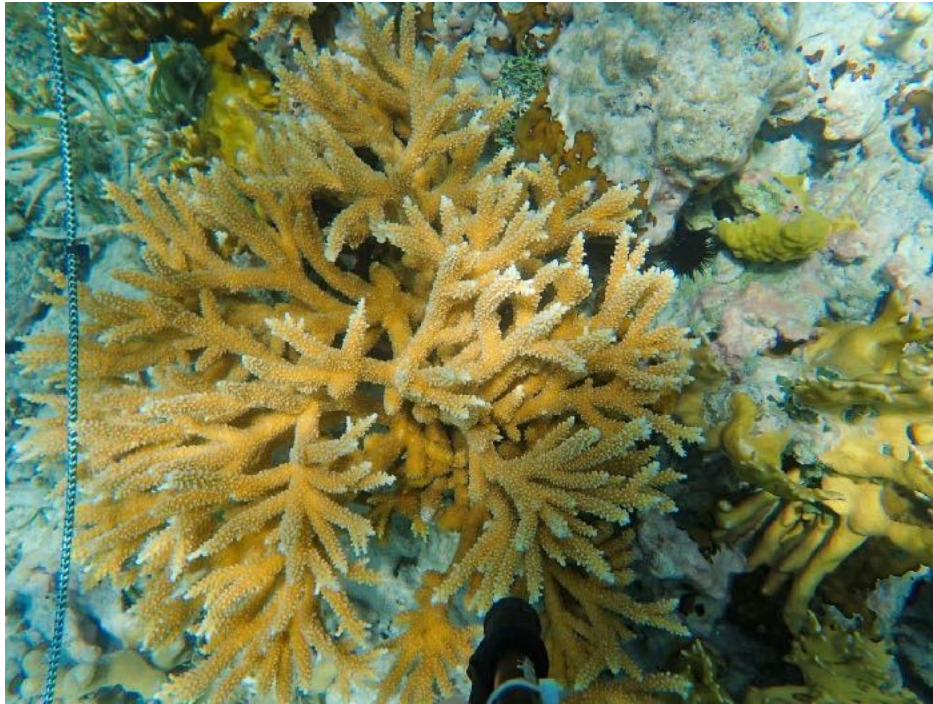
**Photo 5:** Live coral identified in Coral Transect 2 (Camacho, 2021)

T2 was carried out to the northern part of the “Coral Survey” point. The dominant substrate here was live coral, accounting for 47.36% of the benthic cover (Photo 4). Dead coral with algae accounted for 28.41% while macroalgae and seagrass each accounted for 8.15% (Figure 3).

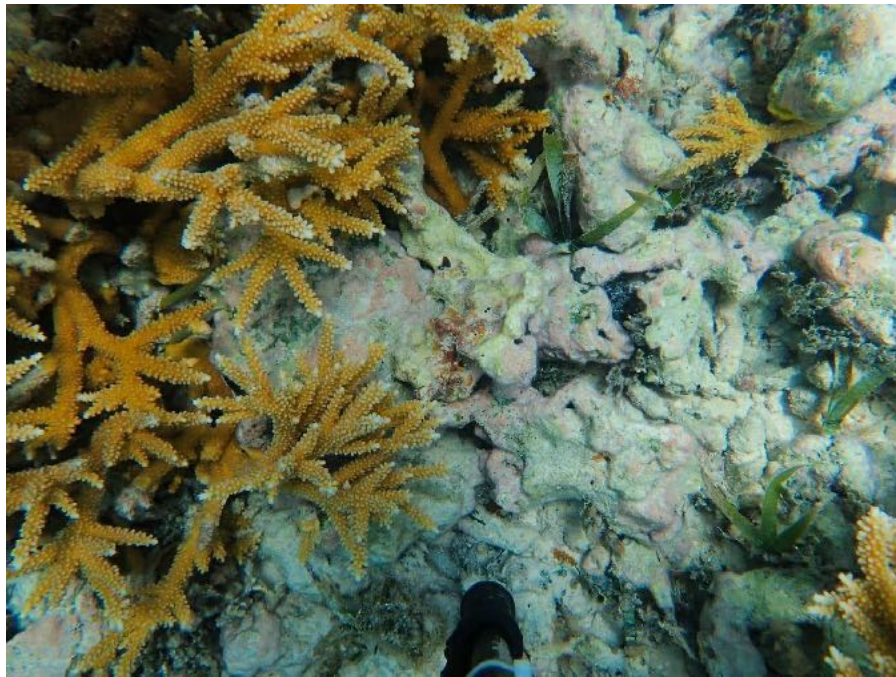
**Photo 6:** Coral Reef Area (Camacho, 2021)

On average, the Live Coral accounted for 23.87% cover, Dead Coral with algae 38.83% and macroalgae accounted for 18.53% (Photo 5).

Although not explicitly surveyed, a variety of fish species were noted at the coral reef sites, and family names are given in Table 5. Additionally, several spot-checks were carried out to better understand the distribution of benthic marine ecosystem displayed in Map 10 utilising the under-water data collection method of Section 3.0.

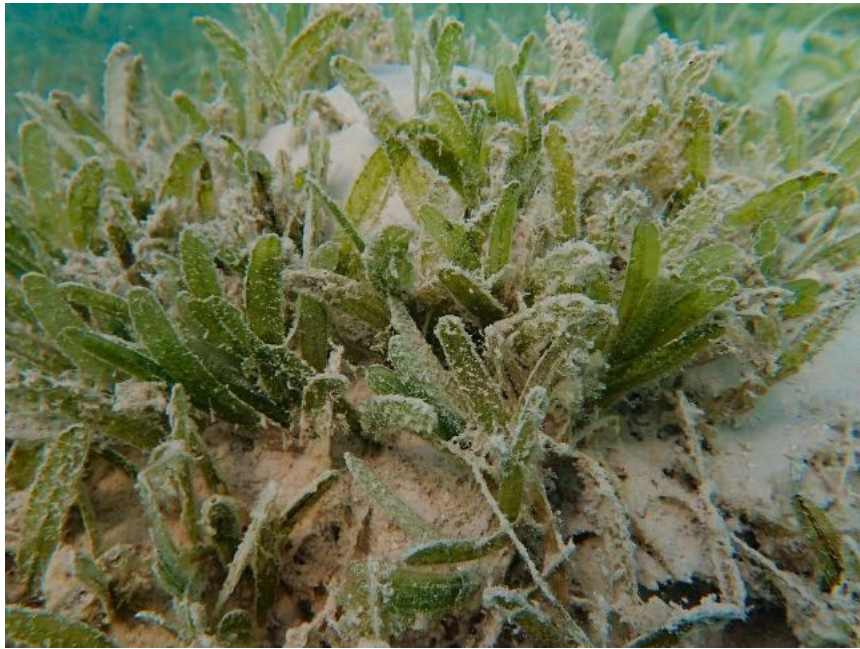
**Photo 7:** Broad-Leaf Seagrass showing sedimentation on Leaves (Camacho, 2021)

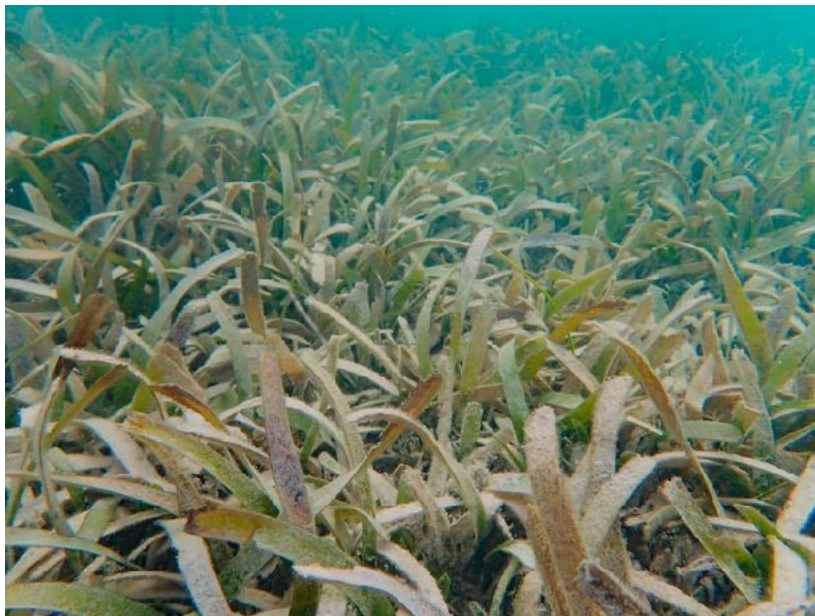
**Photo 8:** Turtle Grass Found in Transect 1 (Camacho, 2021)

In Transect 1, the native seagrass species (Turtle Grass) shown below in Photo 7, accounted for 85% of benthic cover, while the invasive broadleaf species accounts for 3.5% and the remaining 11.5% made up by mud/silt.

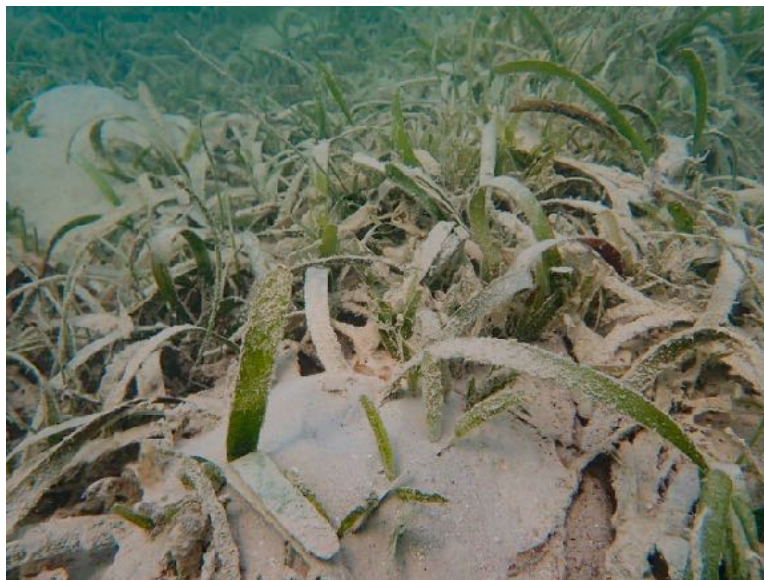
**Photo 9:** Turtle Grass showing significant presence of sedimentation (Camacho, 2021)

In all transects, seagrass blades, particularly the native species, were heavily inundated by sediment shown in Photo 8.

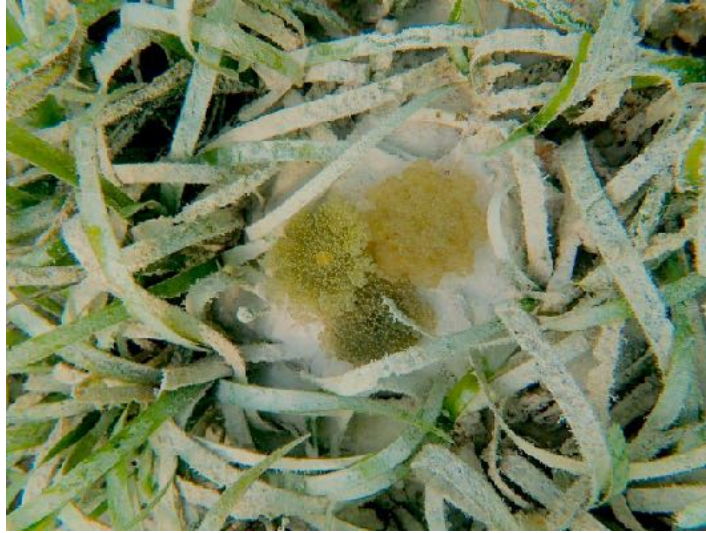
**Photo 10:** Upside-down Jellyfish in Seagrass (Camacho, 2021)

Macro-invertebrates were also observed and varied across transects, with the Upside-down jellyfish (*Cassiopea frondosa* and *Cassiopea xamachana*) in Photo 9 being the most dominant but only seen in Transect 2 (26/100m<sup>2</sup>) and Transect 3 (5/100m<sup>2</sup>).

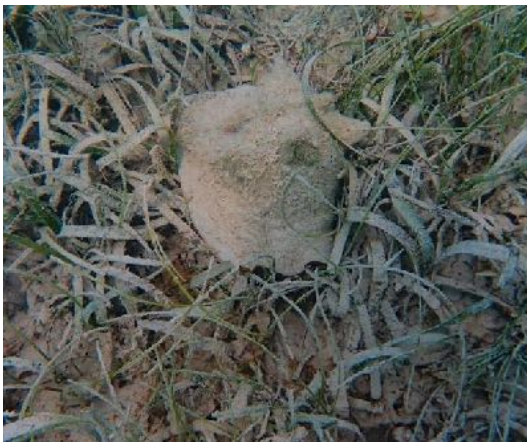
**Photo 11:** Queen Conch  
(Camacho, 2021)

A single Queen Conch (*Aliger gigas*) in Photo 10 was seen in Transect 2, while 6 Cushion Sea Star (*Oreaster reticulatus*) in Photo 11 observed in Transect 6. Figure 5 displays the distribution where macro-invertebrates were observed in Transect 1.
